Kansas City Walkway Tragedy

David DeWolf

MAE 331

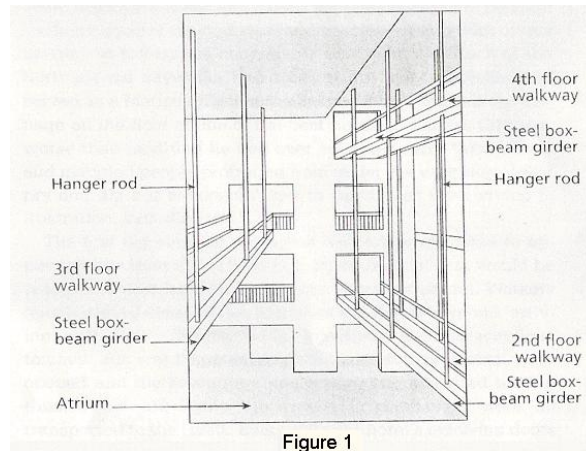
Figure 1

The grand design and the exhilarating architecture were the Hyatt hotels key features. Balconies, glass elevators, huge atriums, and huge skywalks were the extravagating parts which stood out most, which made the Hyatt one of the best social centers in Kansas City and the place to be. There were three 120 foot long suspended skywalks which were suspended from the ceiling. There were two separate skywalks on one side which connect the two buildings on the 2nd and 4th – floors respectively. On the other side was the skywalk which connects at the 3rd story level of building (see Figure 1).

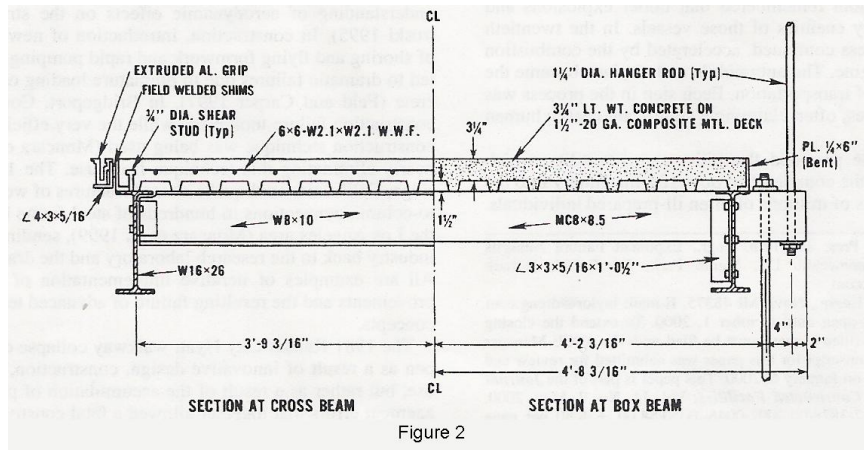
Each bridge was supported at the ends by equidistant intervals by three pairs of hangers suspended from the roof trusses. The walkway decks were formed of lightweight concrete placed over a corrugated metal deck which was supported by two I-beam stringers. These I-beams stringers, W16 X 26, would transfer the weight of the skywalk and superimpose the load to three transverse box beams per bridge. The box beams were

two welded flange-to-flange channel sections of MC8 X 8.5. The 1 ¼ diameter hanger rods passed throughout the center of the weld of the channel flanges and carried the weight transferred by them through a nut and washer installed on the treaded hanger (see Figure 2).

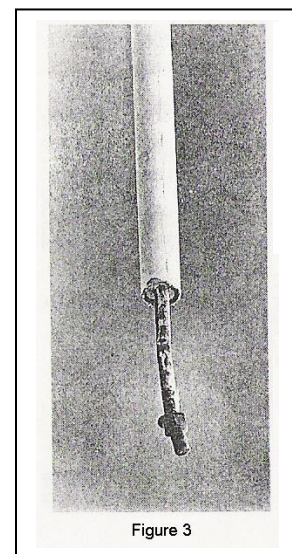
The daunting task of evaluating the wreckage and determining what caused the failure was the next outcome. The hanger rods from which the collapsed skywalks came from were still hanging from suspended from the ceiling with only about six to eight inches looking raw and exposed (see Figure 3). With the nuts and washer still visible on the rods and no evidence of “necking” or in which the diameter of the rods become smaller and smaller to form a neck, it became quite clear that the failure was in the connection rather than the rods themselves. The next questions investigators had to ask was “What caused the collapse?”

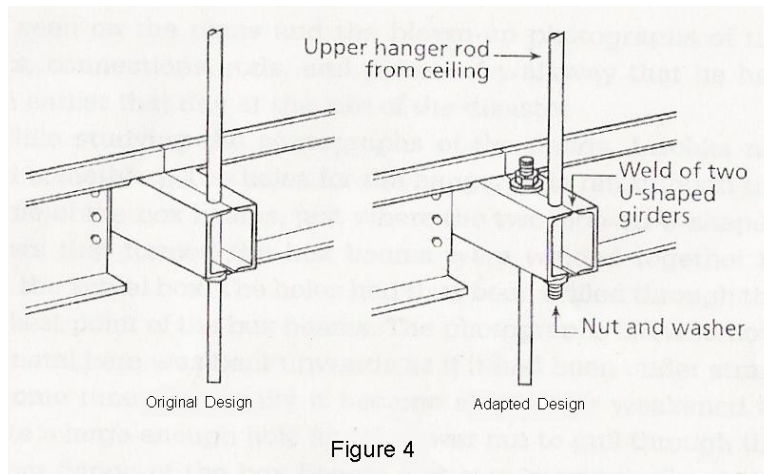
The next step was to look at the design of the skywalk itself. The original plan filled at City Hall required that the 2nd and 4th-floor walkways each hanging on six continuous rods being hung from the ceiling. In this design, the load of each walkway was supported by nuts and washers under each deck on the continuous rod. The as built design had two upper hanger rods, thus suspending the 4th-floor skywalk. It went through the transverse beam box and was supported only by nuts and washers underneath. The two separate, lower hanger rods went through the inner side of the beam box of the 4th-floor skywalk and suspended the 2nd-floor skywalk, again connected with nuts and washers (see Figure 4).

It is quite clear to see why the change was eminent. The original plan was impossible because one would have to raise the heavy decks up the hanger rods without stripping the threads. The original design was adapted to a double rod instead. This design change was a crucial mistake because now the 4th-floor skywalk was carrying the load of itself as well as the 2nd story skywalk load. This is like holding two people up on the same rope with only one set of hands enduring all the strain. On the other hand, if each person was hanging separately on the rope, there would be considerable less strain on your hands. Also the holes for the hanger rods were drilled directly in the middle of the welded beam box, which is already the weakest point. Photographs have shown that

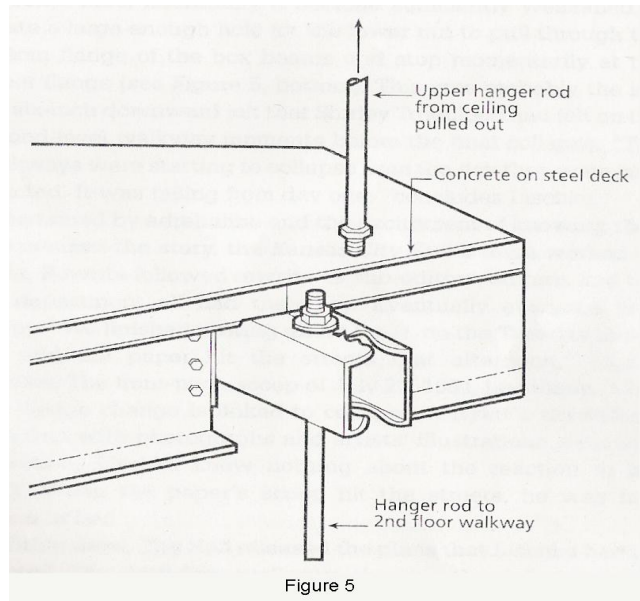
metal was bent upwards as if it were already under considerable strain. Eventually the hanger rod with the nut and washer created a large enough hole to creep through the welded flange-to flange channel beam box to cause this tragedy (see Figure 5).

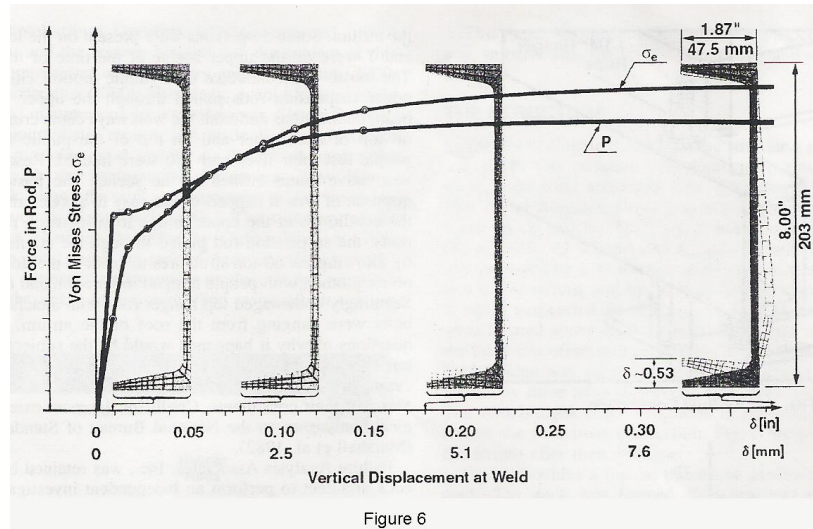
Figure 6

In the succeeding months, investigators took even a closer look at the debris and rubbles. The National Bureau Standards (NBS) concluded that the design was very close to failure margin and was unsafe. In the redesign plan, even without any alterations to the connections, box beams, or the rods, the dead load of the walkway was greater than what was specified. The actual dead load was 1300 lbs or about 8% more than the computed dead load. The corrugated steel deck and concrete made up the difference not shown on the original drawings. The extra weight took the walkway even closer to the edge as cameras have shown that there were about 63 people on the walkways or an approximate of 9,450 lbs of live load. The Kansas City Building Code required that at least 72,000 lbs per walkway or a total of 144,000 lbs. Therefore the walkway collapsed with a live load of about 1/15 the safe applicable load. From a finite-element study, the dead load level, the plastic deformation of the channel flanges was about 0.1 to 0.15 inches. This magnitude couldn't obviously be noticed by the naked eye since steel construction was covered by a finish and fireproofing. Experimental and analytical studies have shown minimal impact on the ultimate capacity of the connection by the weld. The finite element analysis showed the importance of the channel flange stiffness to the stress in which cause the failure (see Figure 6).
